Firmware V2.23 Release Note

Firmware Release V2.23

- NWA3160-N V2.23(UJA.8)C0
- NWA3550-N V2.23(UJB.8)C0
- NWA3560-N V2.23(UJC.8)C0

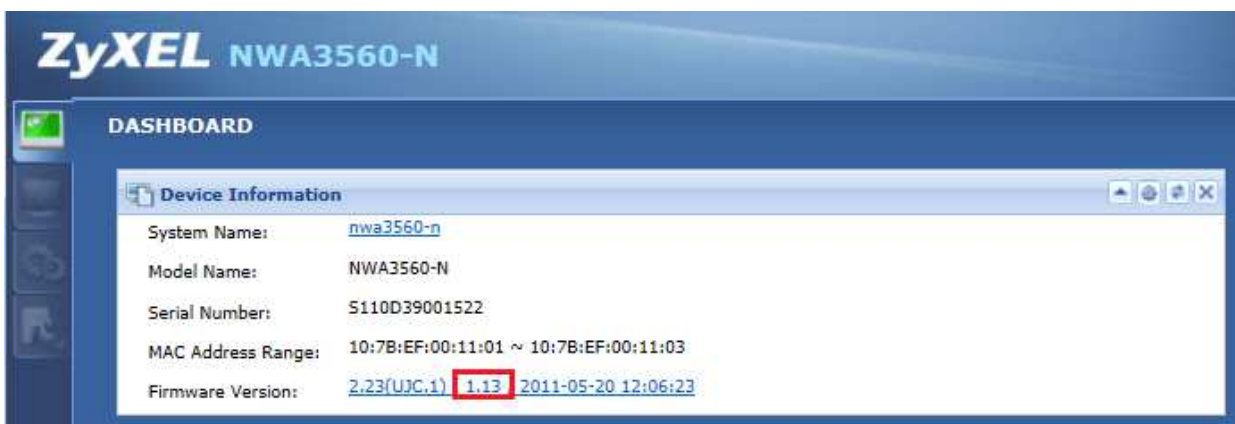
1. If the boot code version of NWA3000-N series AP is 1.13, before the AP to be managed by ZyXEL AP controller (NXC series), firstly the AP must upgrade to the exact firmware version: **V2.23(UJA.2)/V2.23(UJB.2)/V2.23(UJC.2)**. Please refer to [Appendix - B: Firmware Upgrade Procedure](#).
