Firmware V2.23 Release Note

Firmware Release V2.23

ZyXEL Access Points

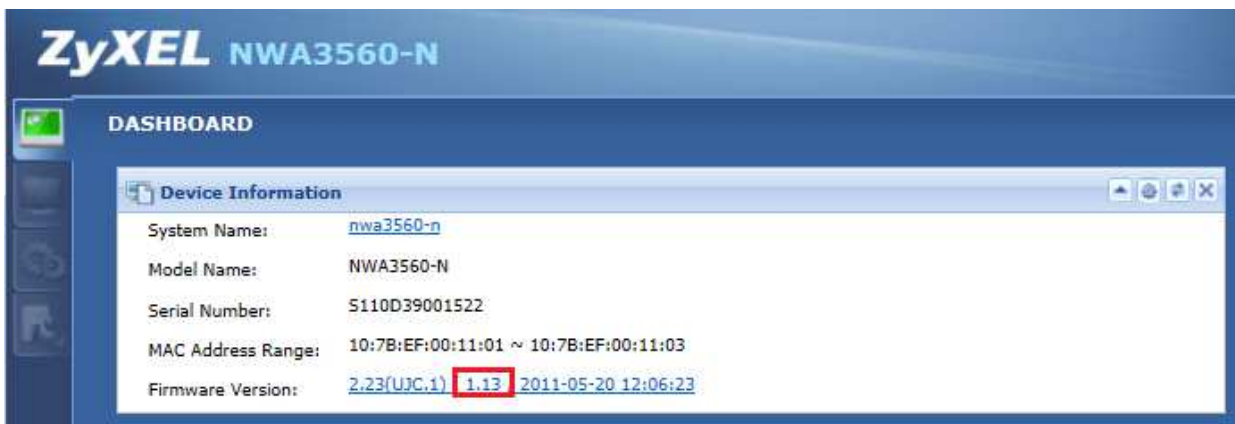
1. If the boot code version of NWA3000-N series AP is 1.13, before the AP to be managed by ZyXEL AP controller (NXC series), firstly the AP must upgrade to the exact firmware version: **V2.23(UJA.2)/V2.23(UJB.2)/V2.23(UJC.2)**. Please refer to [Appendix - B: Firmware Upgrade Procedure](#).
